***Lake Lemon***  
***Aquatic Vegetation Management Plan***  
***2006 Update***  
February 13, 2007

Prepared for:  
Lake Lemon Conservancy District  
7599 North Tunnel Road  
Unionville, IN 47486

Prepared by:  
Aquatic Control, Inc.  
PO Box 100  
Seymour, Indiana 47274

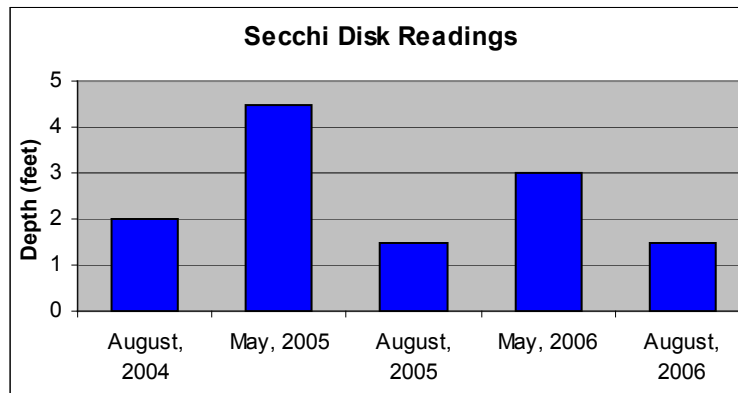
Figure 7. Lake Lemon, comparison of Secchi Disk readings in the last five surveys.

One of the primary goals of the vegetation management plan is to preserve and enhance the native plant community. The main limitation to native plant growth in Lake Lemon is the lack of light penetration caused by dense algae blooms. These blooms typically occur in late July or August. The blooms were not as severe this season, but they did occur by our August sampling (Figure 7). There appears to be no significant change in the August Secchi reading over the past three seasons.

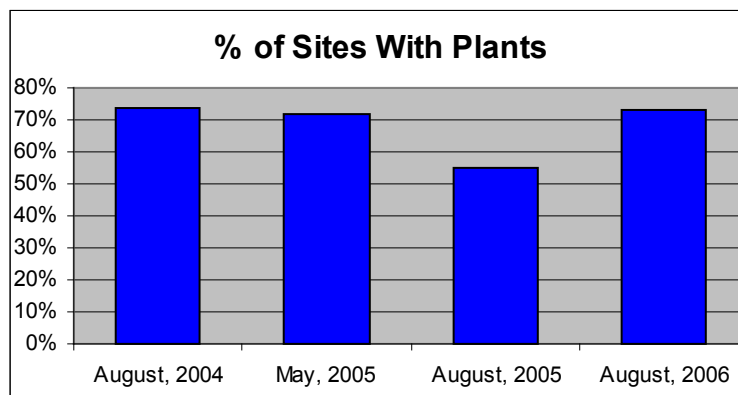
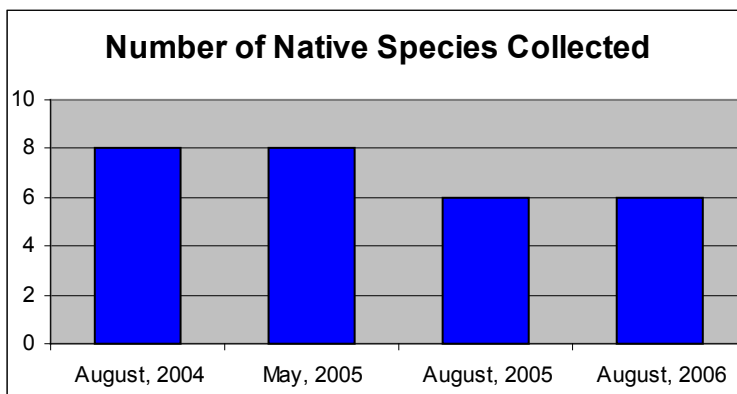
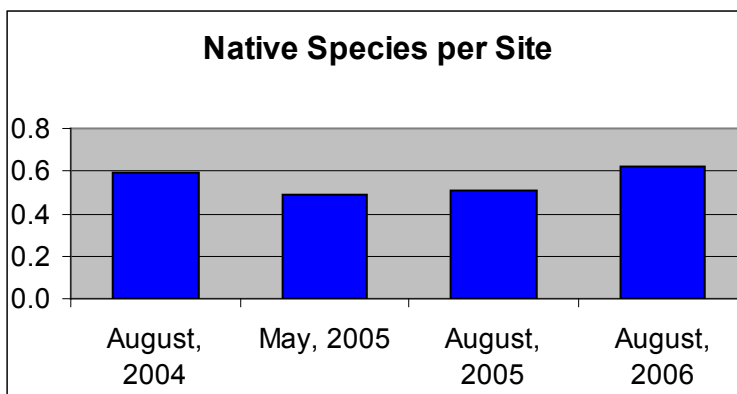
It appears that the overall abundance and diversity of native vegetation was not negatively impacted by this season's vegetation controls. There was an increase in treatment of native vegetation this season, but the native metrics remained the same or increased (Figure 8, 9,& 10). This is an indication that controls can take place to reduce the nuisance levels of these species while still maintaining diversity throughout the lake. Ideally, these metrics would increase in the future as Eurasian watermilfoil is controlled.

Figure 8. Lake Lemon, comparison of the percentage of sites with plants in the last four surveys.

Figure 9. Lake Lemon, comparison of the number of native species collected in the last four surveys.

Figure 10. Lake Lemon, comparison of the average number of native species per sample site in the last four surveys.

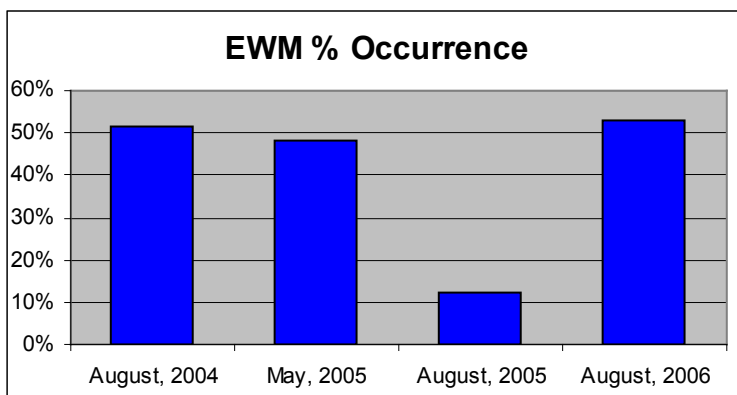
Figure 11. Lake Lemon, comparison of Eurasian watermilfoil percent occurrence in the last four surveys.

Another goal of the vegetation management plan is to reduce the negative impacts caused by Eurasian watermilfoil. The May tier I survey indicated a reduction in milfoil density, especially in the large area in the east end of the lake that was treated last season. Due to a reduction in funding and a lack of LLCD funds, it was decided that only areas of milfoil that interfered with access would be treated. Many beds outside of the high use areas were not treated. This allowed for the milfoil beds to expand and infest new areas. The results indicate that milfoil frequency of occurrence increased by the August sampling (Figure 11).

The 2006 treatments effectively controlled Eurasian watermilfoil in the treated areas, but as previously mentioned, there were several areas of milfoil that did not receive treatment. These areas continued to spread throughout the season. In 2007, it is recommended that the LLCD funds treatment of nuisance plant growth in the high use areas with LLCD funds, no matter if they are treating native vegetation or Eurasian watermilfoil. Treatments in these areas should be completed with contact herbicides that are not selective to milfoil. On several occasions these high use areas would be treated twice, once for milfoil and then once for native plants. In order to insure season long control the contact herbicide treatment should be held off until early to mid June. This will allow for control through much of the busy season (if treatment takes place in May it is likely that nuisance levels of vegetation could return by late July). The LARE funds could then be designated for treatment of milfoil beds in the lower use areas, which were not treated in 2006.

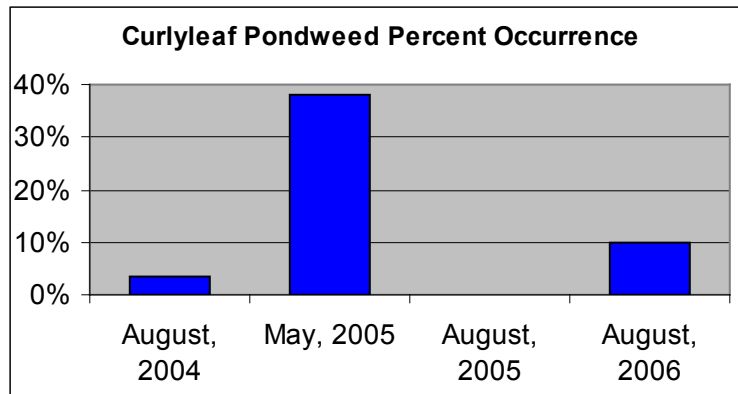
Figure 12. Lake Lemon, comparison of curlyleaf pondweed percent occurrence in the last four surveys.

Curlyleaf pondweed reached nuisance levels in several areas in the spring of 2007. This species has historically not been a problem in Lake Lemon, but appears to be spreading. There was not a tier II survey completed in the spring of this season, but it was one of the most abundant species in the tier I survey. A strange phenomenon occurred this year where curlyleaf pondweed did not senesce like it typically does in the summer. This plant was present at 10% of the summer sample sites in the 2006 survey compared to no sites in 2005 (Figure 12). This species should be closely monitored in future surveys.

It is difficult to estimate how much milfoil will require treatment next season, so it is our recommendation that the LLCD asks for the same amount that was requested last season. Two surveys should also be completed in 2007 to monitor the plant community. A tier I survey should be completed in May and a tier II survey in August. The Tier I survey will provide maps that can be used to designate late spring treatment areas and the Tier II survey will help monitor the success of the controls. Special attention should be paid to curlyleaf pondweed abundance in the spring surveys. If this species continues to spread, a different action strategy may be needed.

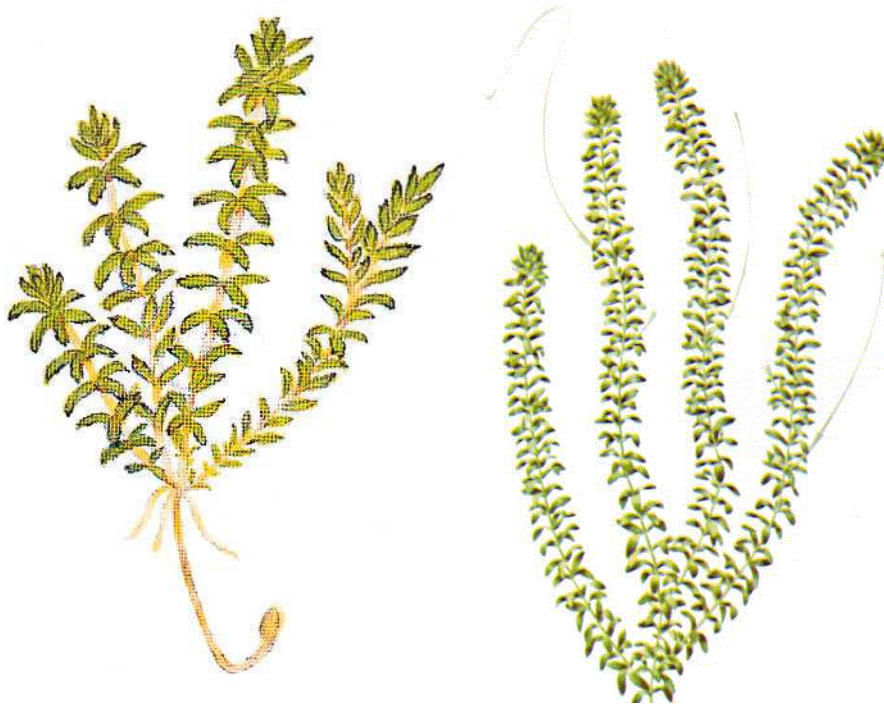
Another topic discussed at the public meeting was the recent discovery of Hydrilla (*Hydrilla verticillata*) in Lake Manitou. Hydrilla is an invasive aquatic species that was originally discovered in Florida in the 1960's. There are many characteristics of hydrilla that make it a threat to Indiana waterways. This species can grow in lower light conditions than most native species, grows faster than most native species, and can shade out other species by forming a surface canopy. Hydrilla can be easily confused with

native elodea. The best way to distinguish Hydrilla is that it typically has five leaves along each whorl along with visible serrated edges along the leaf margin (Figure 14). What makes controlling the spread of Hydrilla difficult is the fact that it can be spread by fragments. **That is why it is vitally important that lake users remove all plants and sediment from their boats when entering and leaving Lake Lemon.** More information about controlling the spread of Hydrilla can be found at [www.protectyourwaters.net](http://www.protectyourwaters.net).

Figure 18. Illustration of Hydrilla on the left compared to native elodea on the right. Hydrilla typically contains five toothed leaves per whorl while native elodea typically has three leaves per whorl and the teeth are not visible on the leaves (Illustrations provided by Applied Biochemist).
